**CONSENT ORDER
ISSUED UNDER THE
WATER POLLUTION CONTROL ACT
WEST VIRGINIA CODE, CHAPTER 22, ARTICLE 11**

TO: Mountain Valley Pipeline, LLC
Attn: Robert J. Cooper
Senior Vice President, Engineering and Construction
625 Liberty Ave, Ste 1700
Pittsburgh, PA 15222

DATE: April 19, 2019

ORDER NO.: 8951

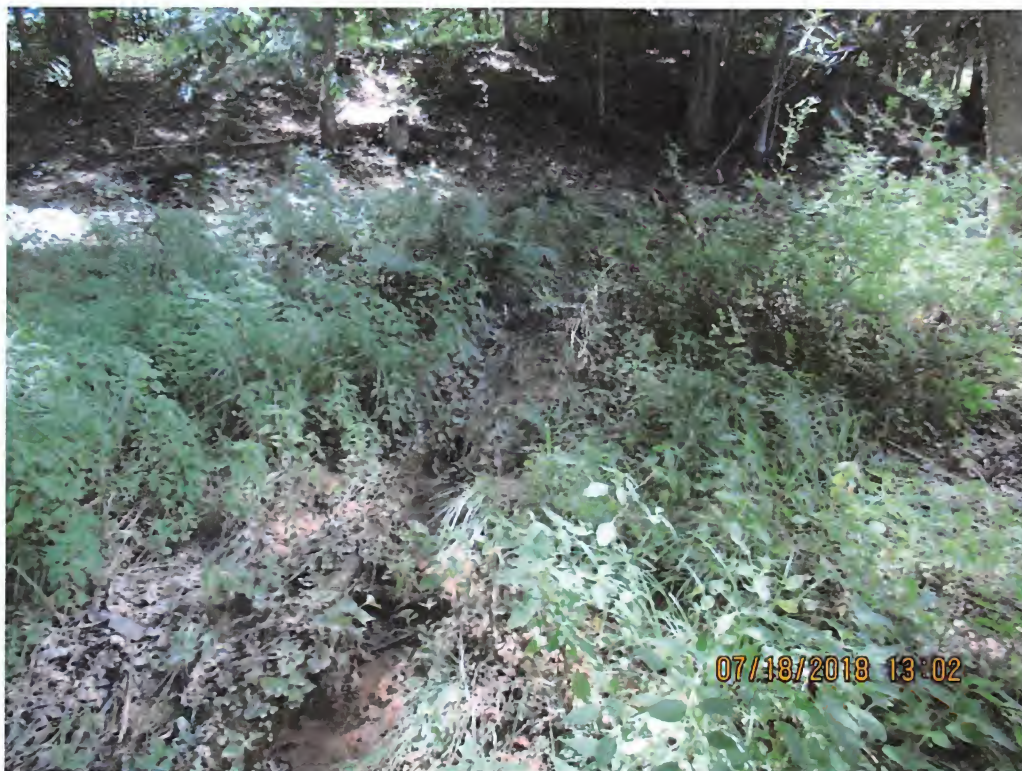
Photo 11: Down gradient of control failure from Photo 10. Photo #7 shows terminus of this control failure.

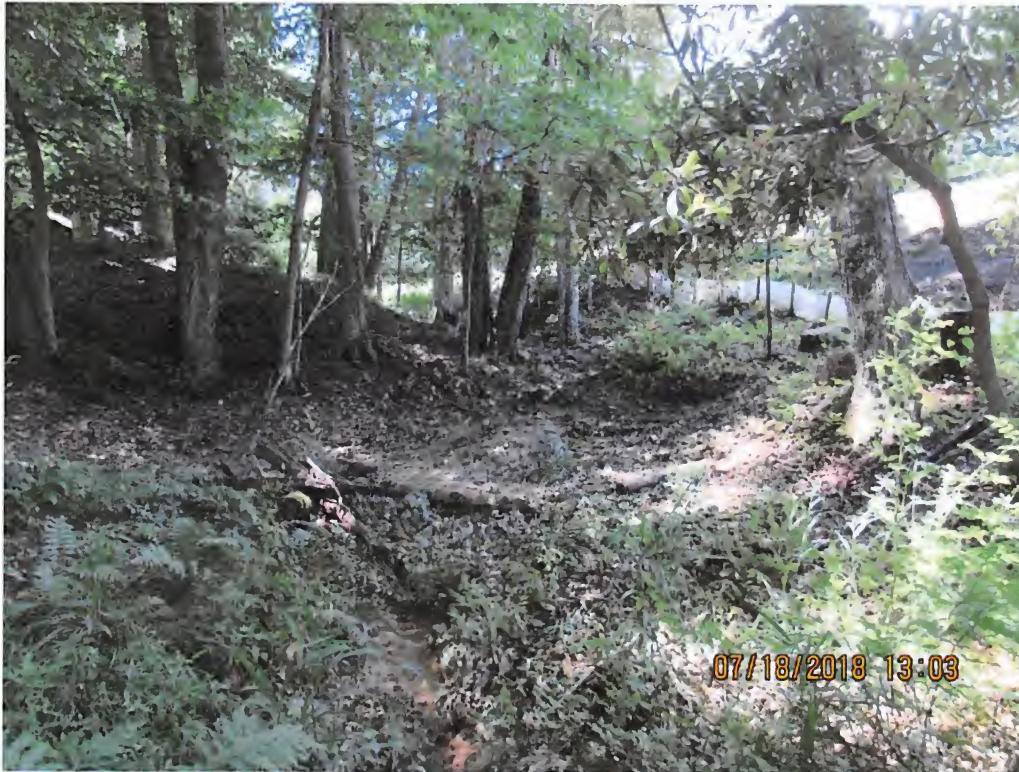
Photo 12: Terminus of sediment laden water leaving site from control failure near station 6785+50 (between MP 128.3 & 128.5)

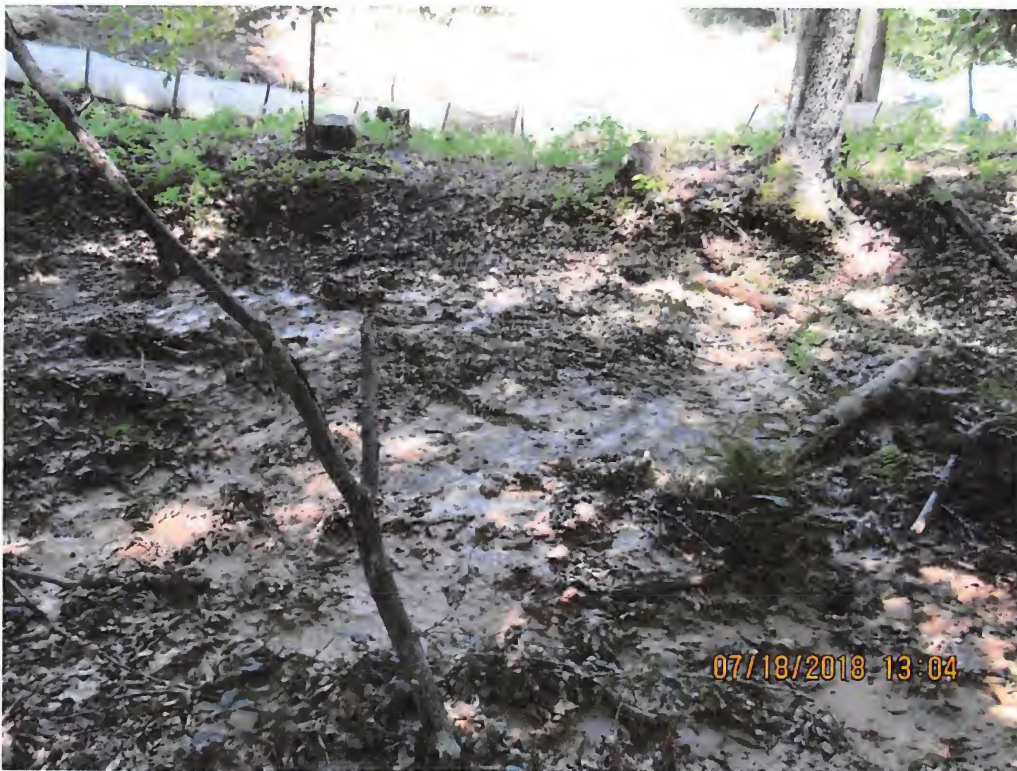
Photo 13: Up gradient of terminus of sediment laden water leaving site.

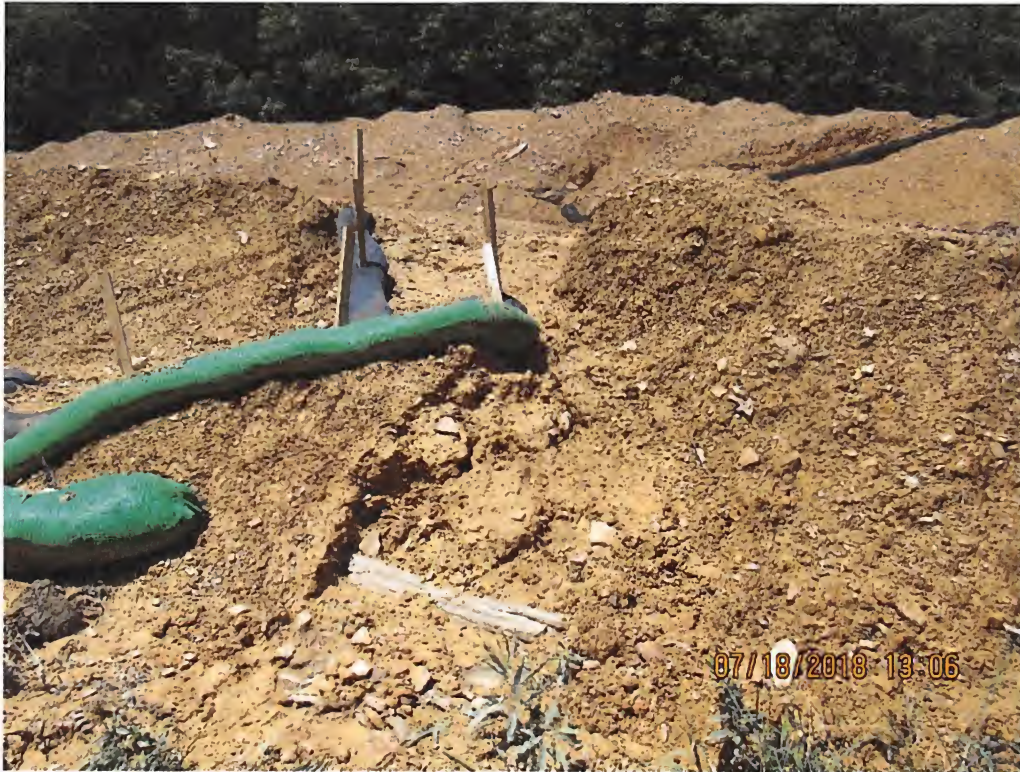
Photo 16: Down gradient view of scour from control failure at 6785+50.

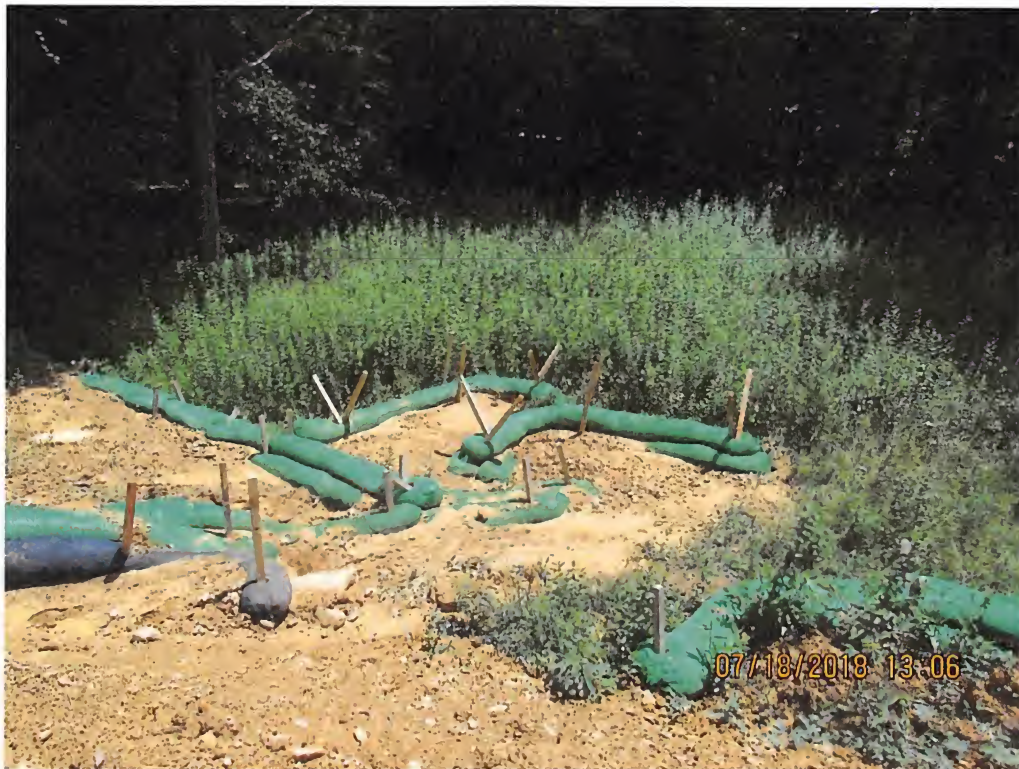
Photo 17: Erosion gullies from failed control at end of water bar near station 6785+50, which allowed sediment laden water to leave site.

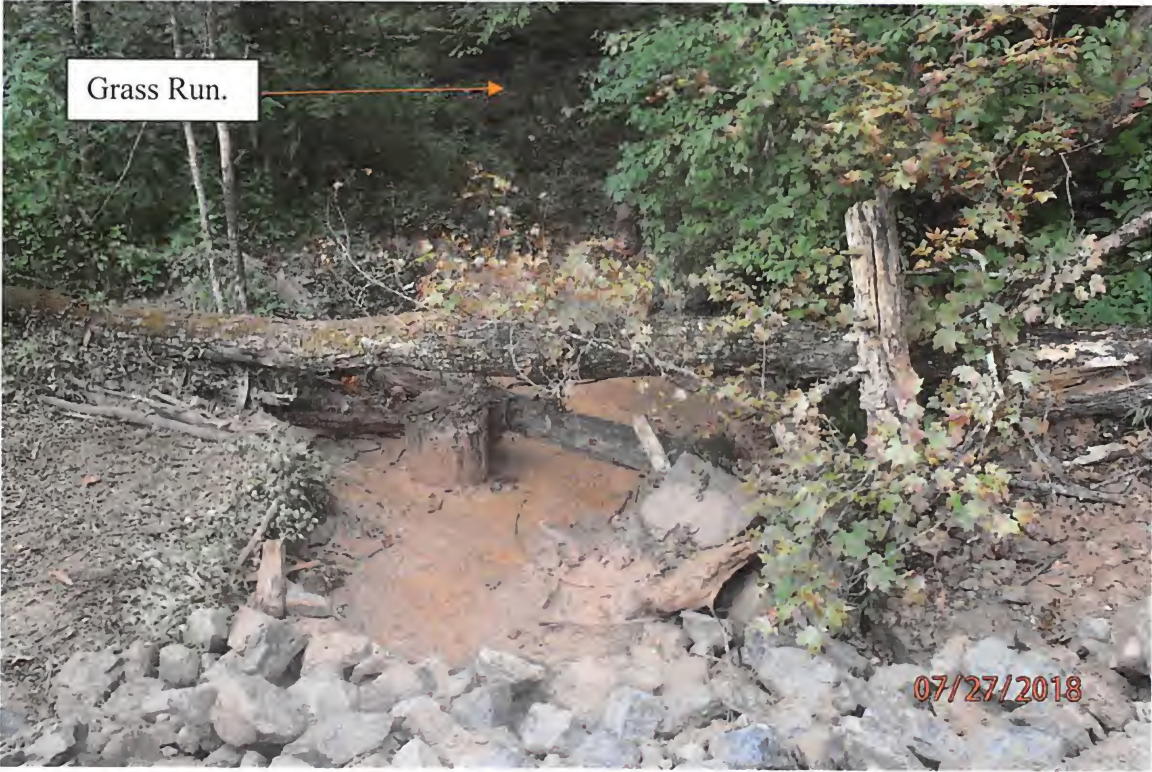
Overview of Grass Run crossing.

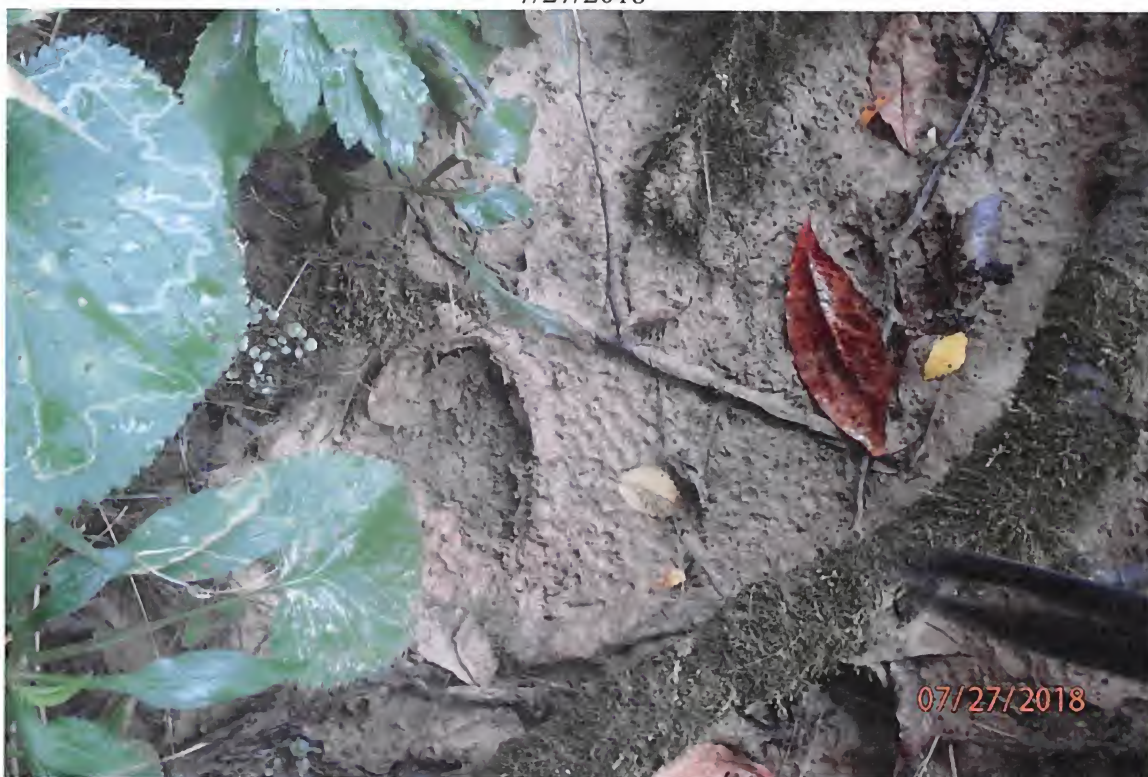
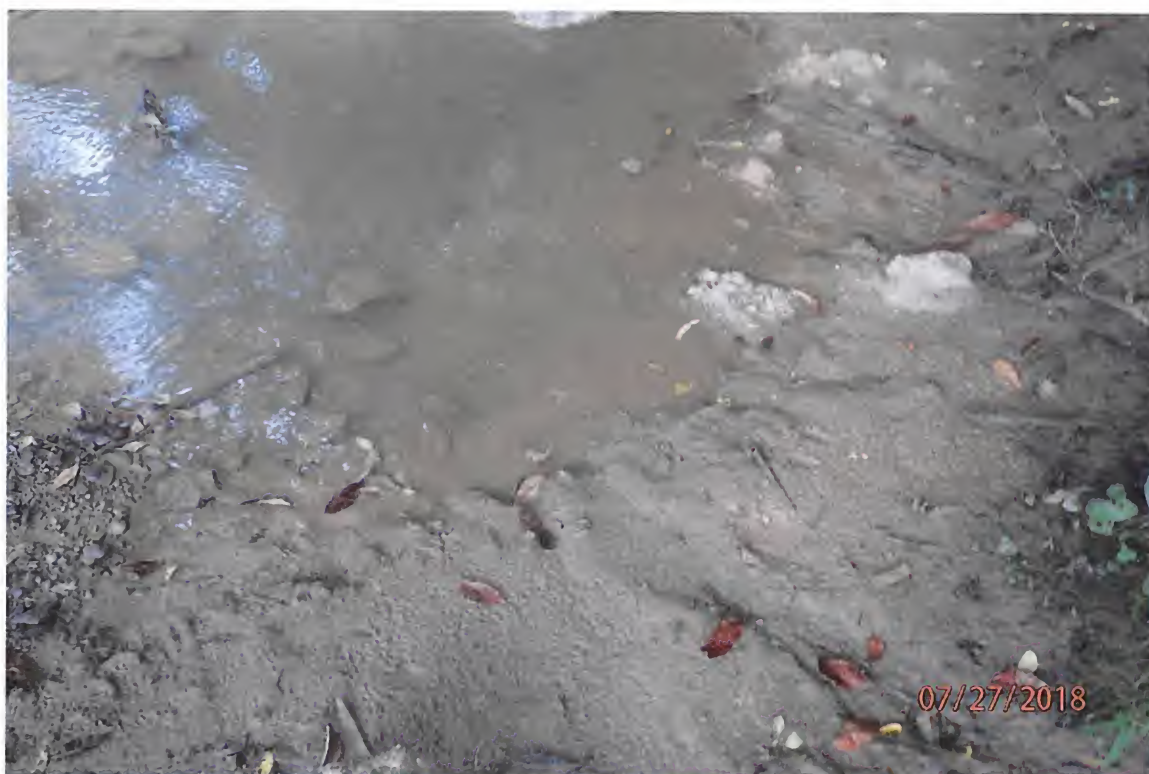
Point where sediment leaves the site.

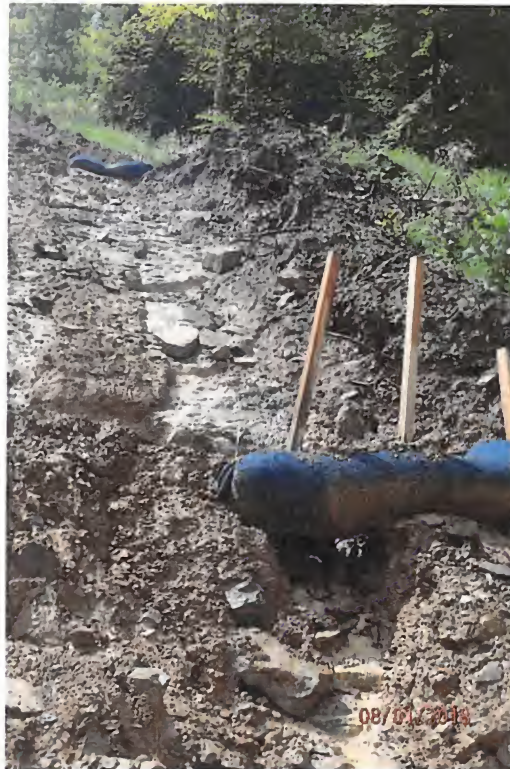
Water bar that lacked outlet protection was noted upslope of grass run adjacent to 1142+00.

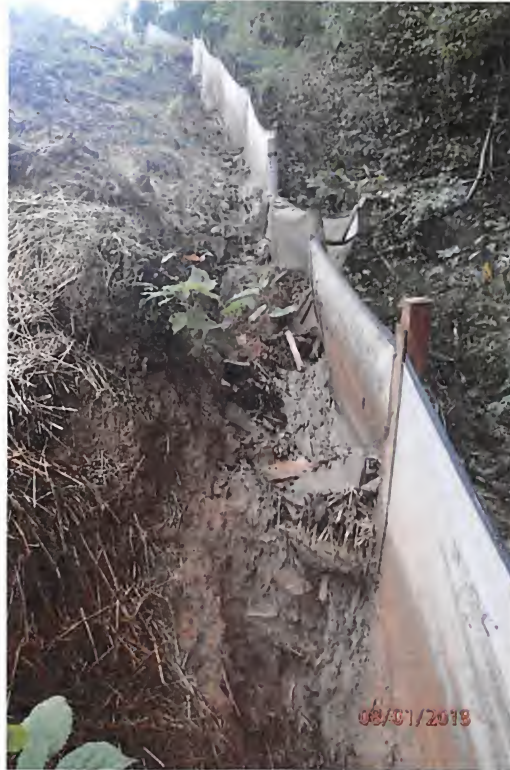
Improperly installed and poorly maintained water bars in the Goose Run watershed.

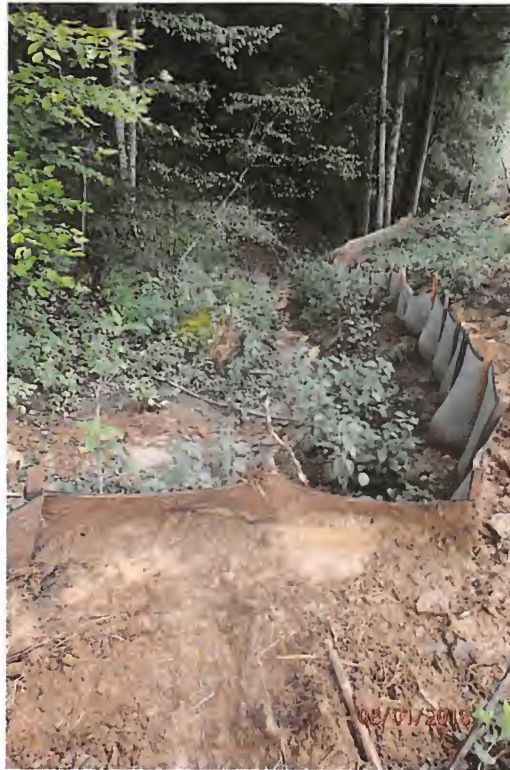
Concentrated flow being channeled along perimeter control trench due to improperly installed water bars in the Goose Run watershed.

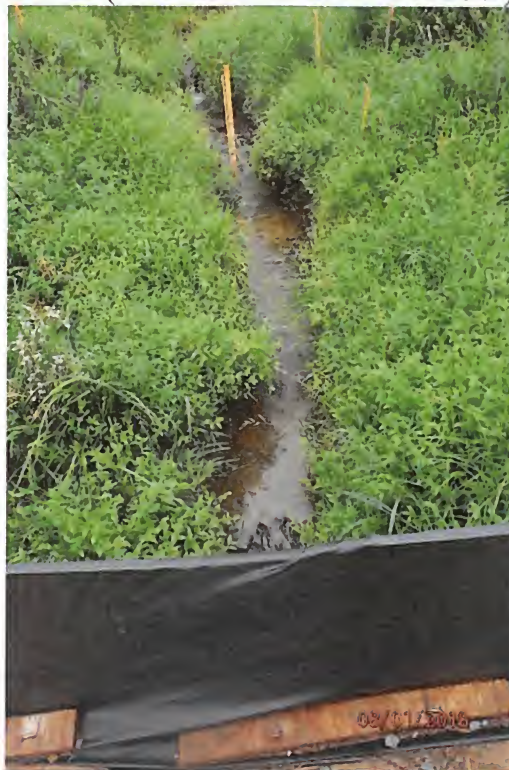
Visible plume in Goose Run (39° 26.17952' X 80° 28.5256') originating from site.

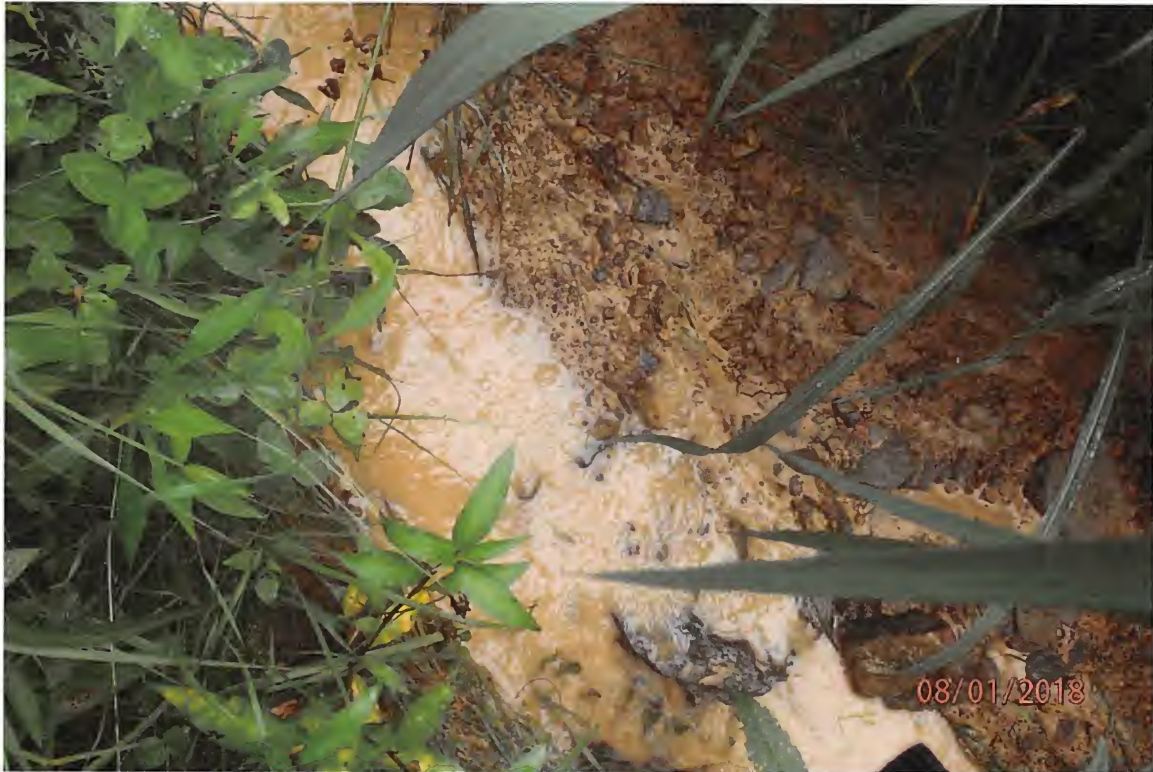
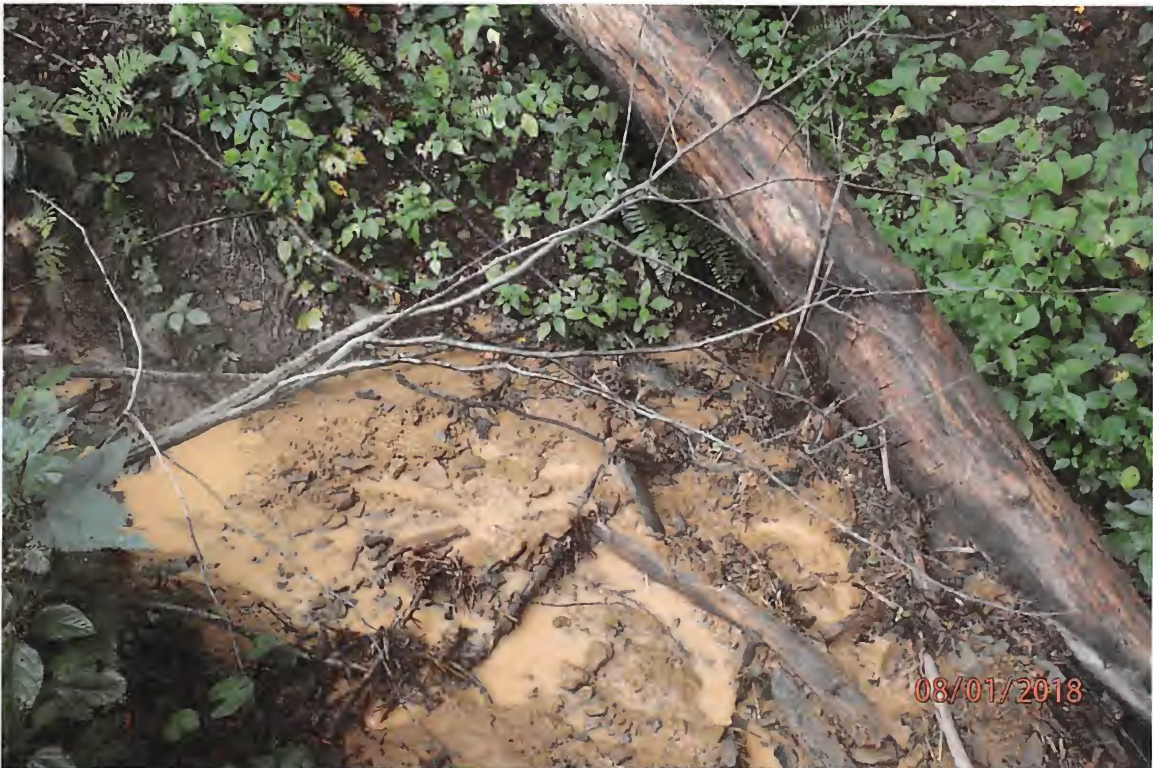
Perimeter controls adjacent to Goose Run that are undermined and allowing sediment laden water to leave the site.

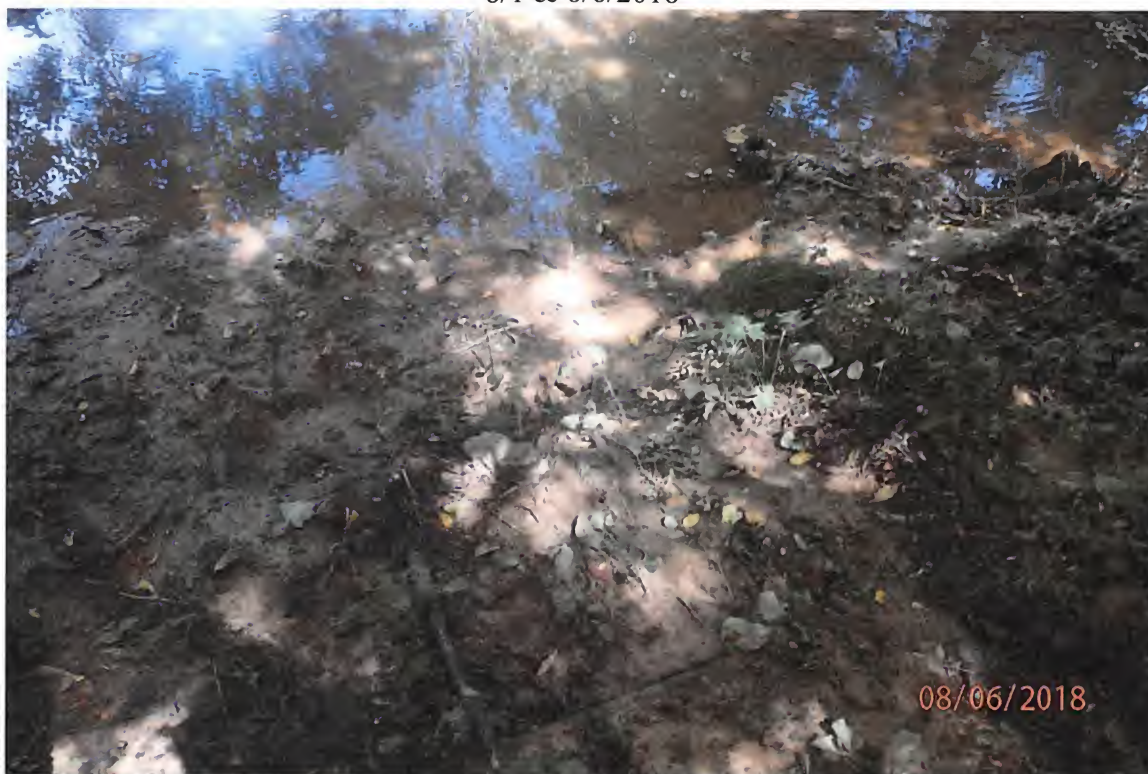
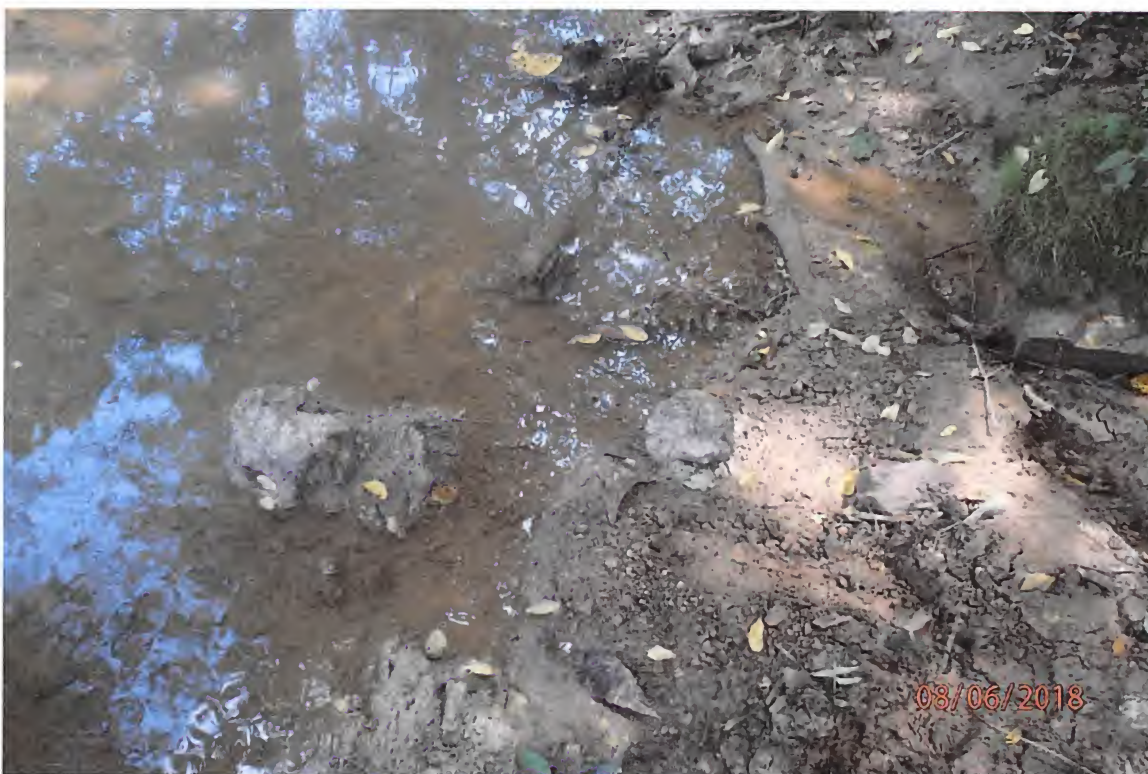
Offsite sediment deposits in Grass Run watershed that lead from site to the receiving stream due to above pictured issue.

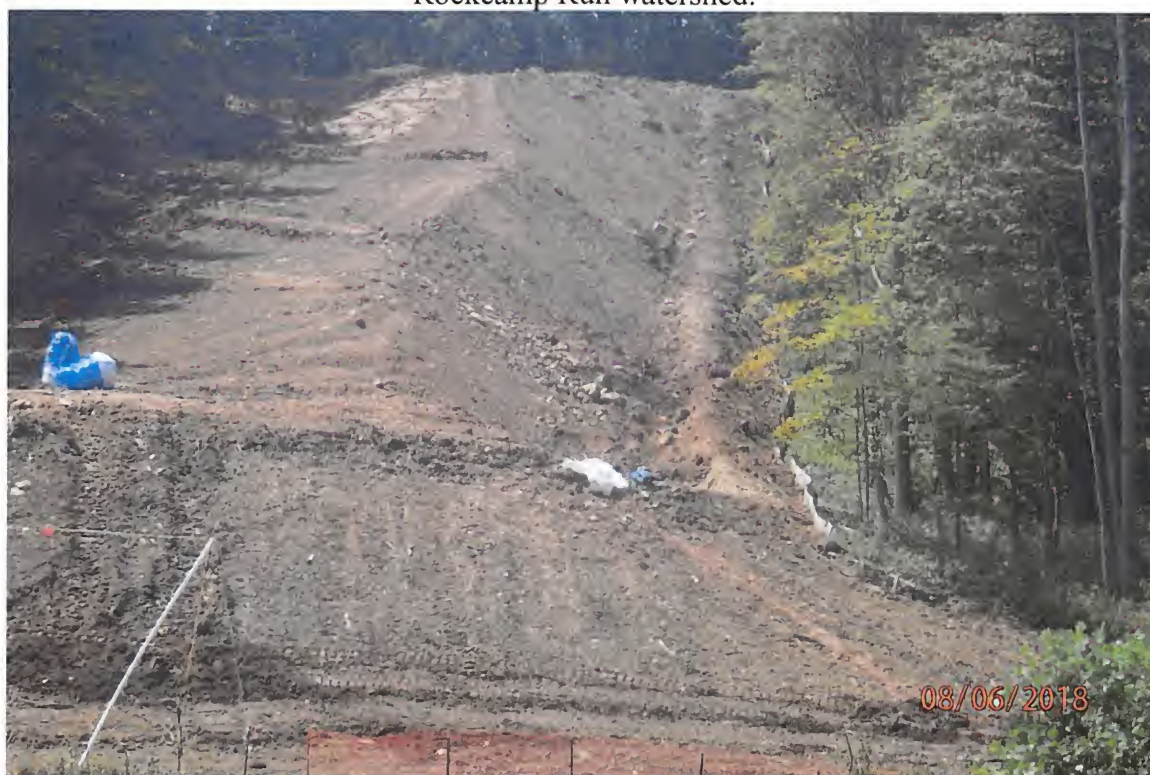
Rockcamp Run watershed.

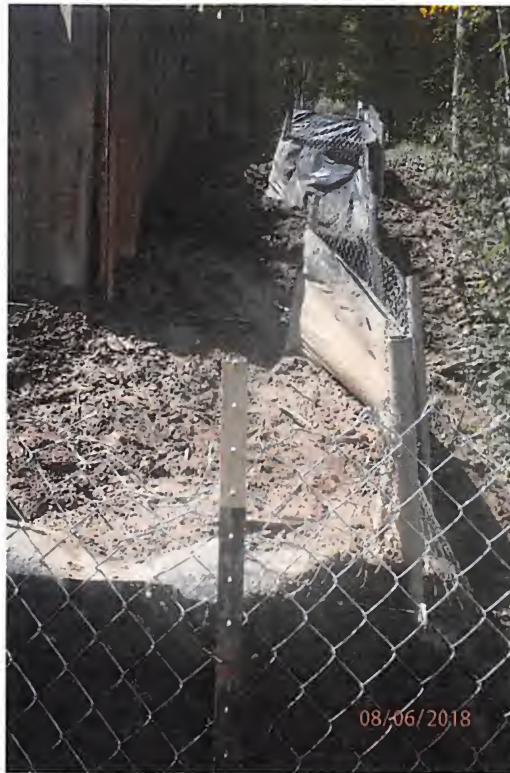
Unstable diversions that collect stormwater from water bar outlets and direct the concentrated flow downslope.

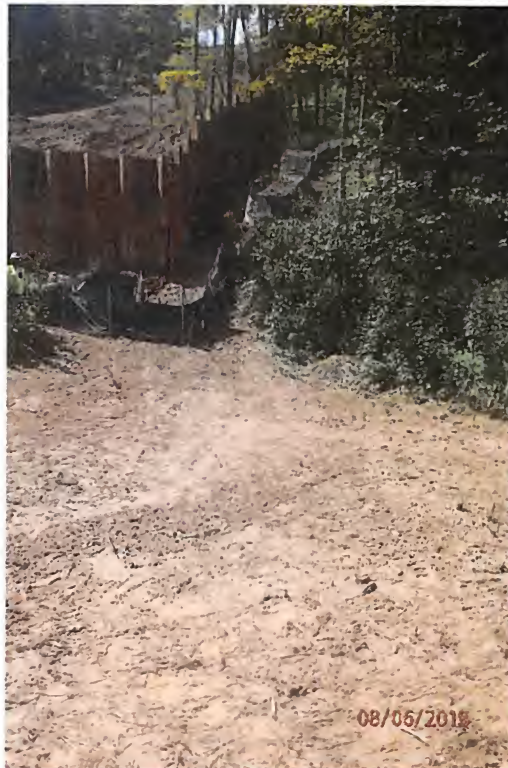
Sheet flow BMP adjacent to Rockcamp Run that is being utilized to treat concentrated flow from previously pictured unstable diversion that collects stormwater from water bars.

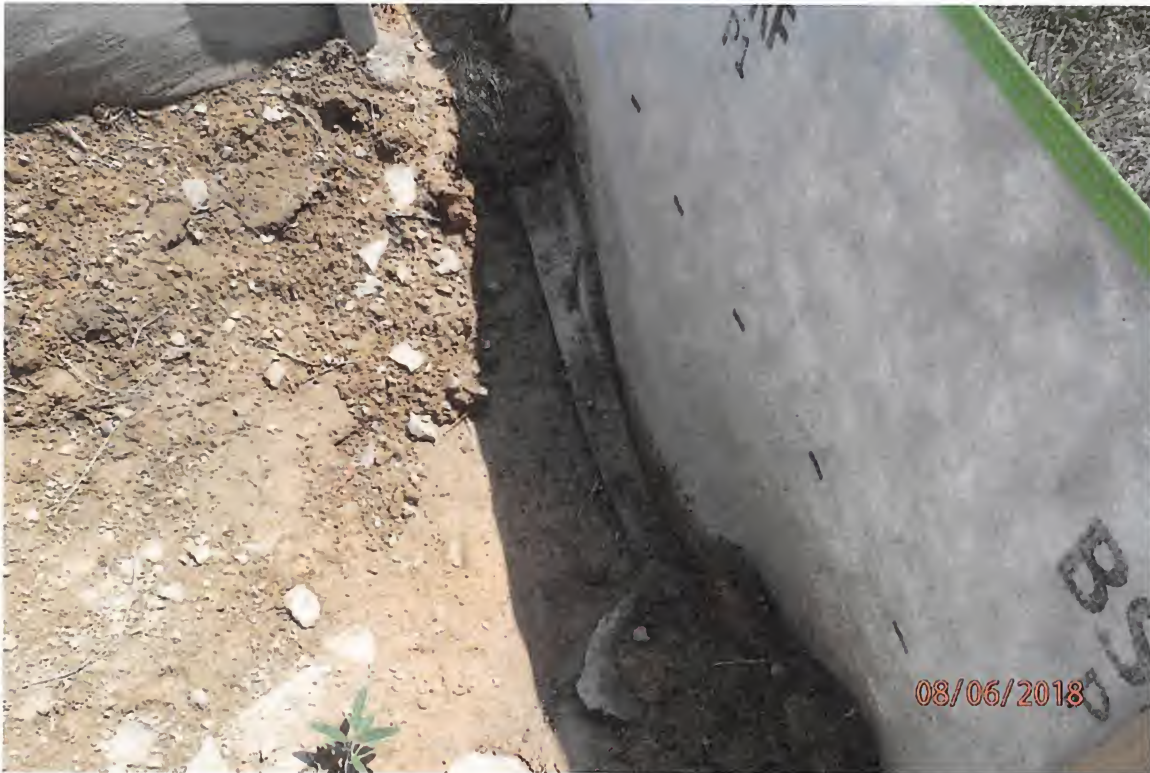
Offsite sediment deposits associated with the overwhelmed BMP at Rockcamp Run.

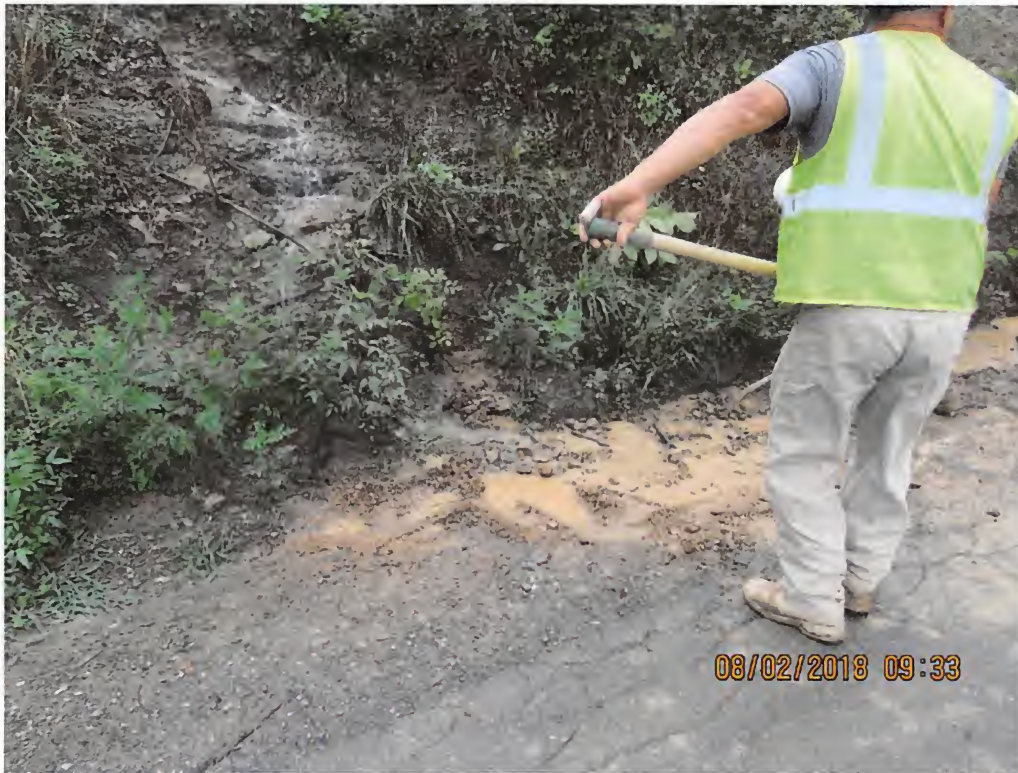
Area adjacent to wetland (W-UU1) in the Salem Fork watershed that lacks the BMPs that are indicated in the approved SWPPP.

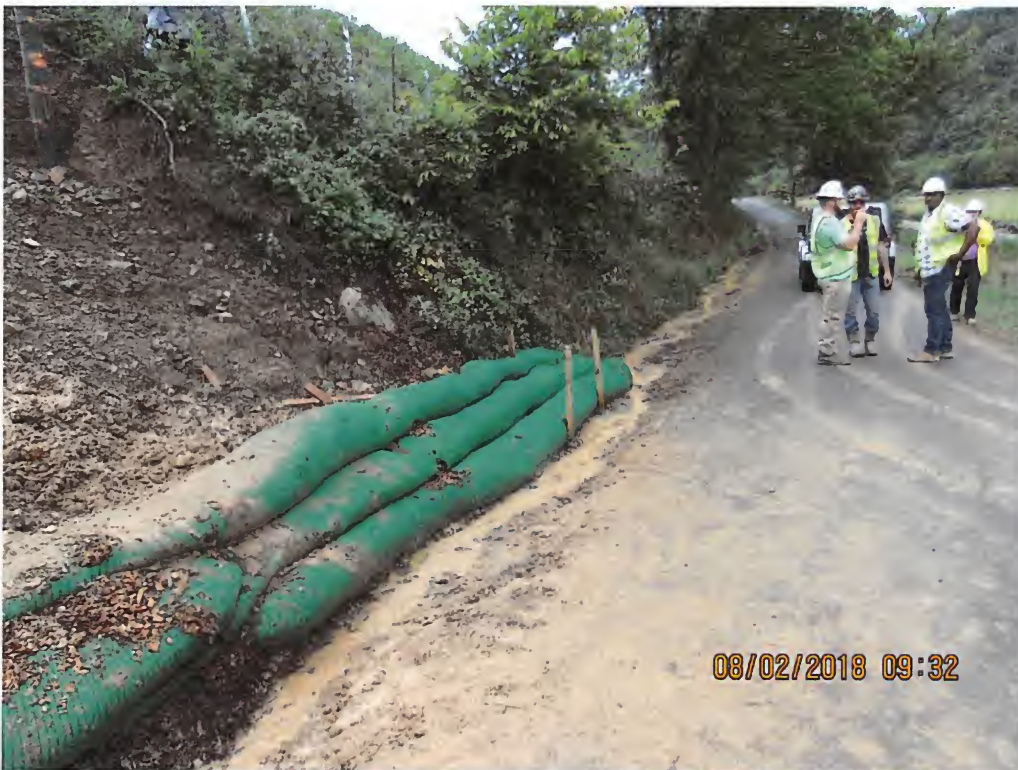
Water bar discharge mixing with sediment in road side ditch with crew performing maintenance.

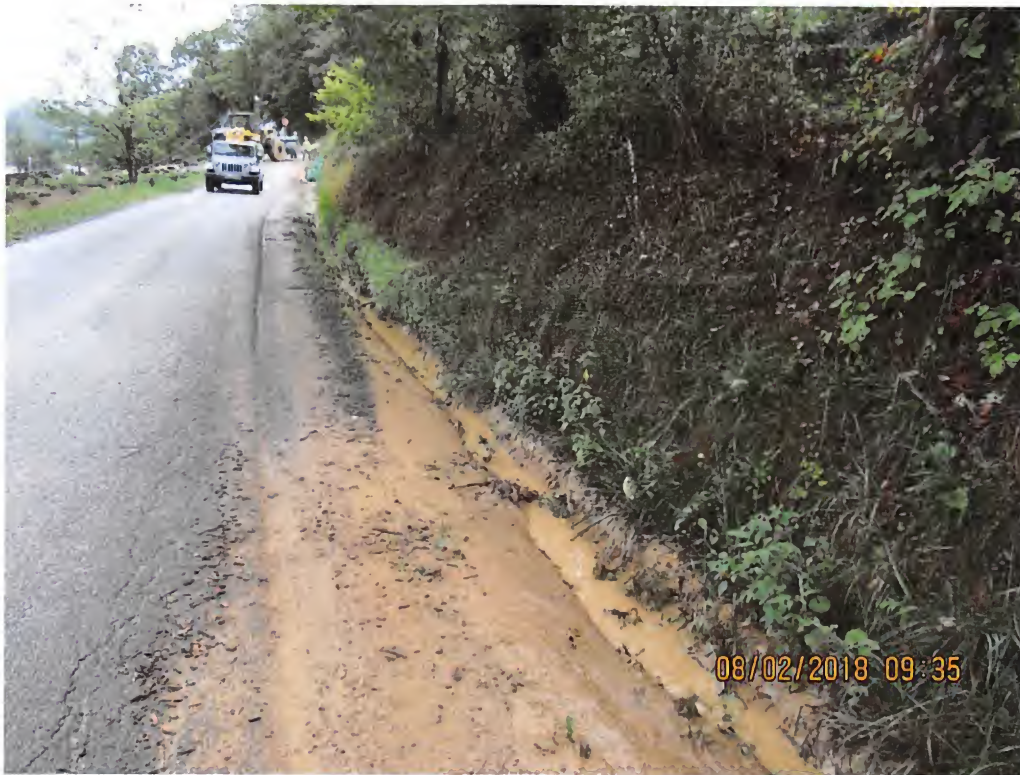
End of road side ditch prior to culvert diverting to laydown yard.

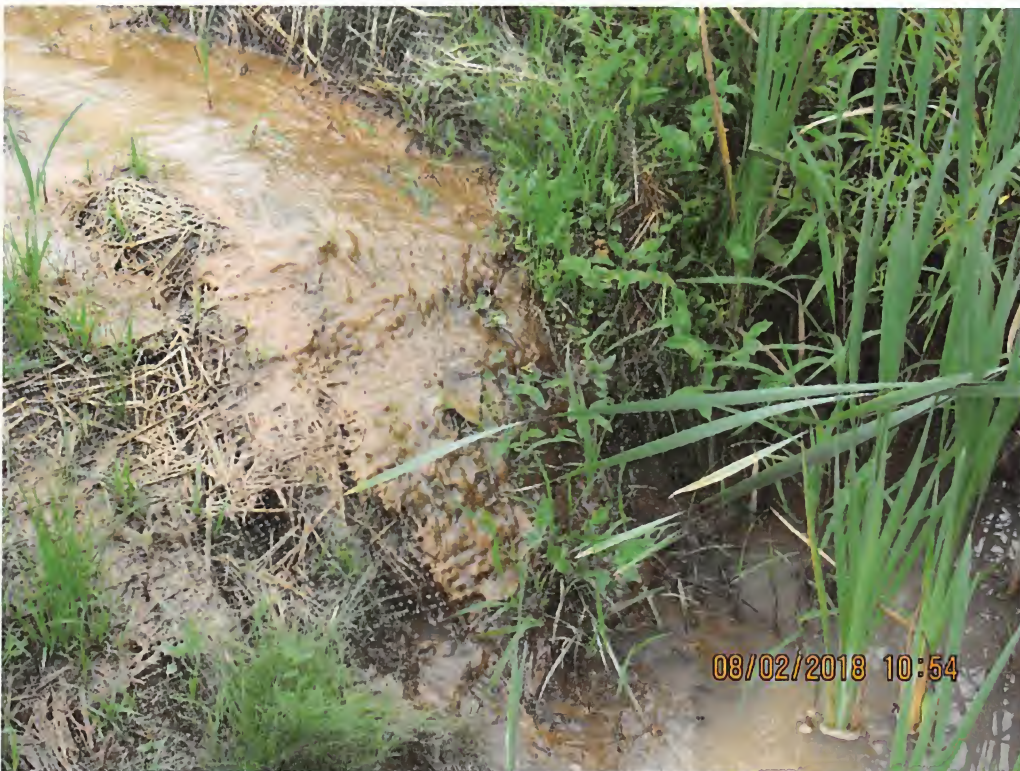
Sediment has been deposited on bank protection product, which is being picked back up prior to entering stream

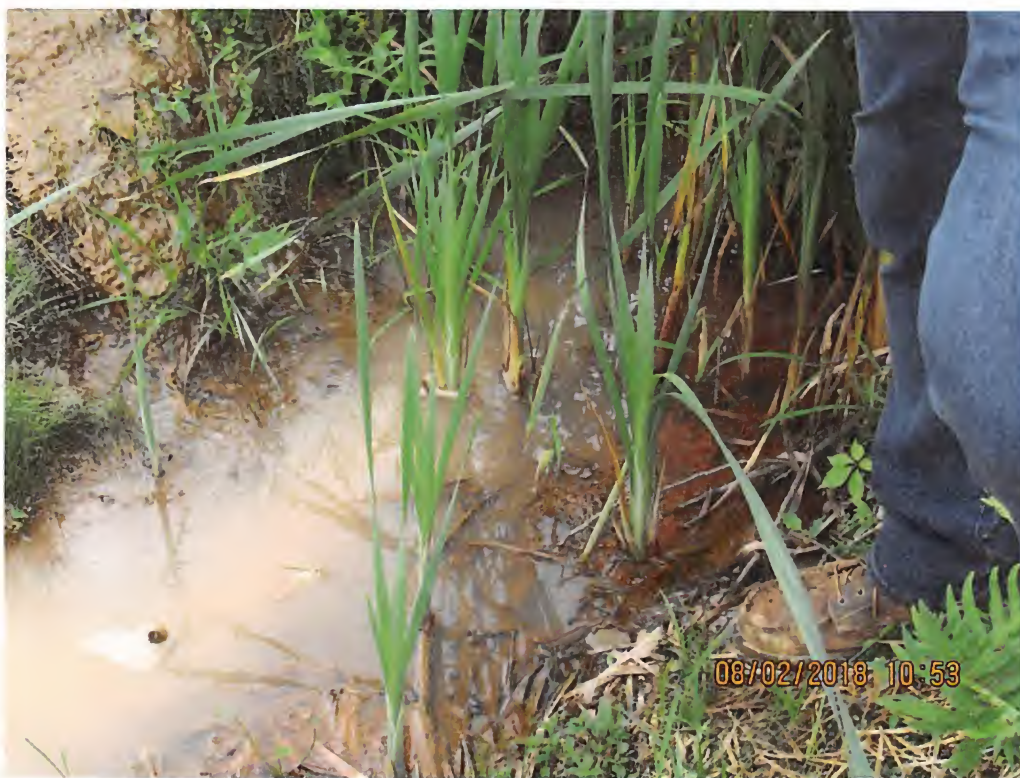
Sediment plume entering Stony Creek

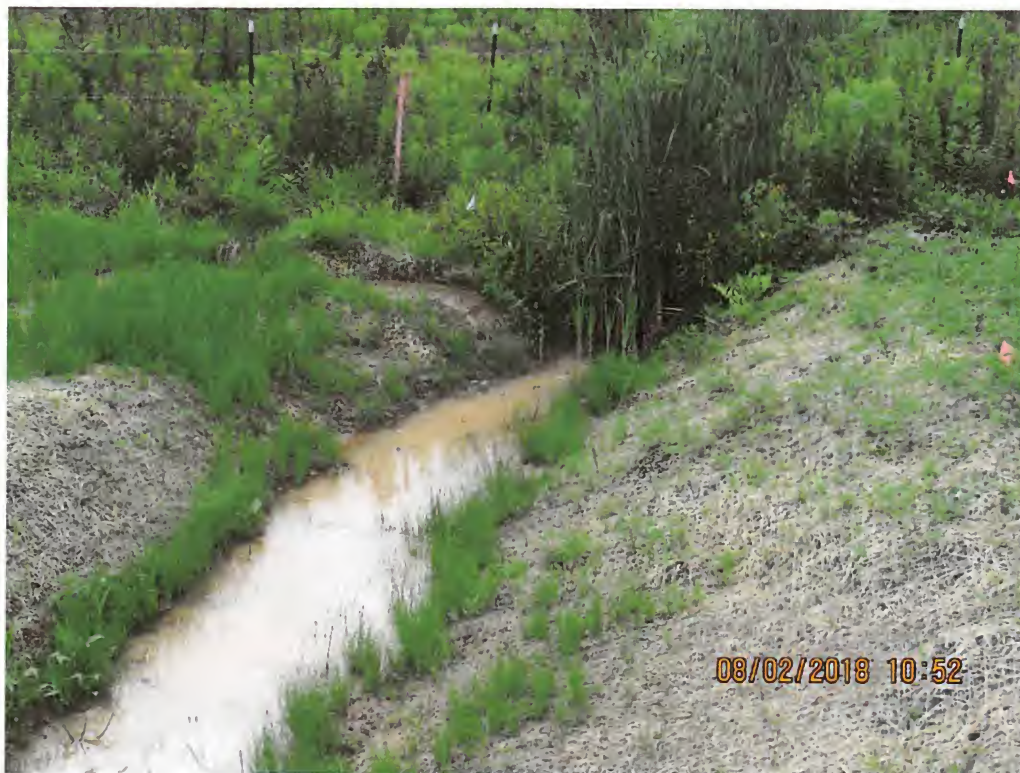
Stony Creek below sediment plume entering stream.

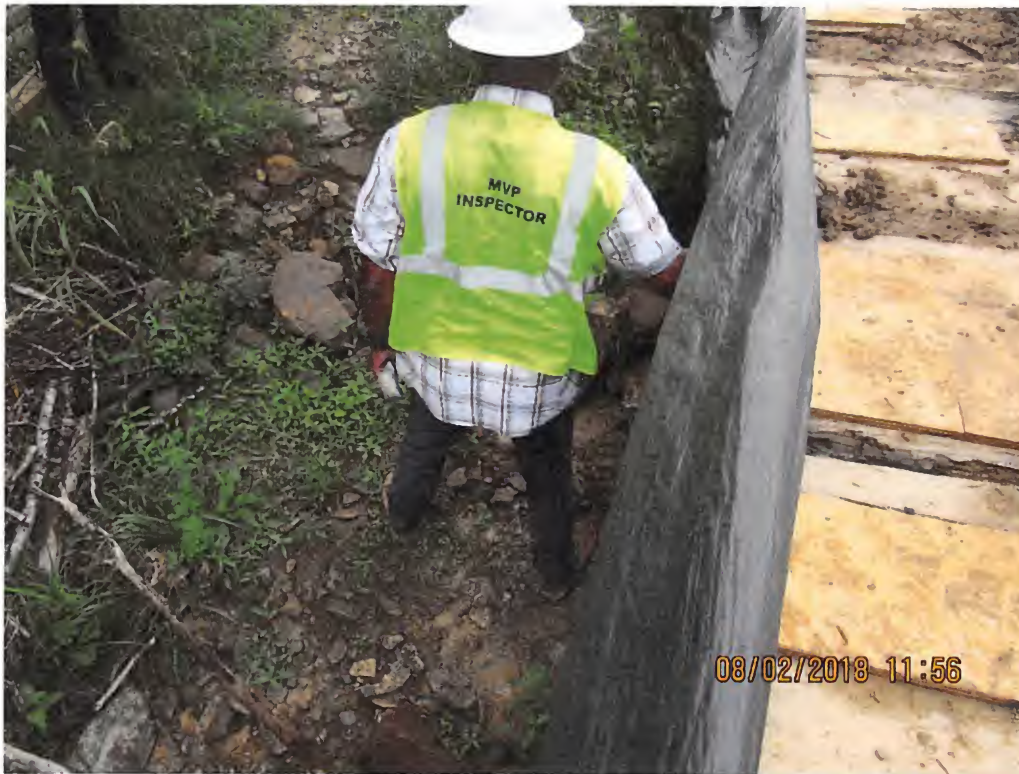
Sediment deposits observed below base of Slate Run bridge.

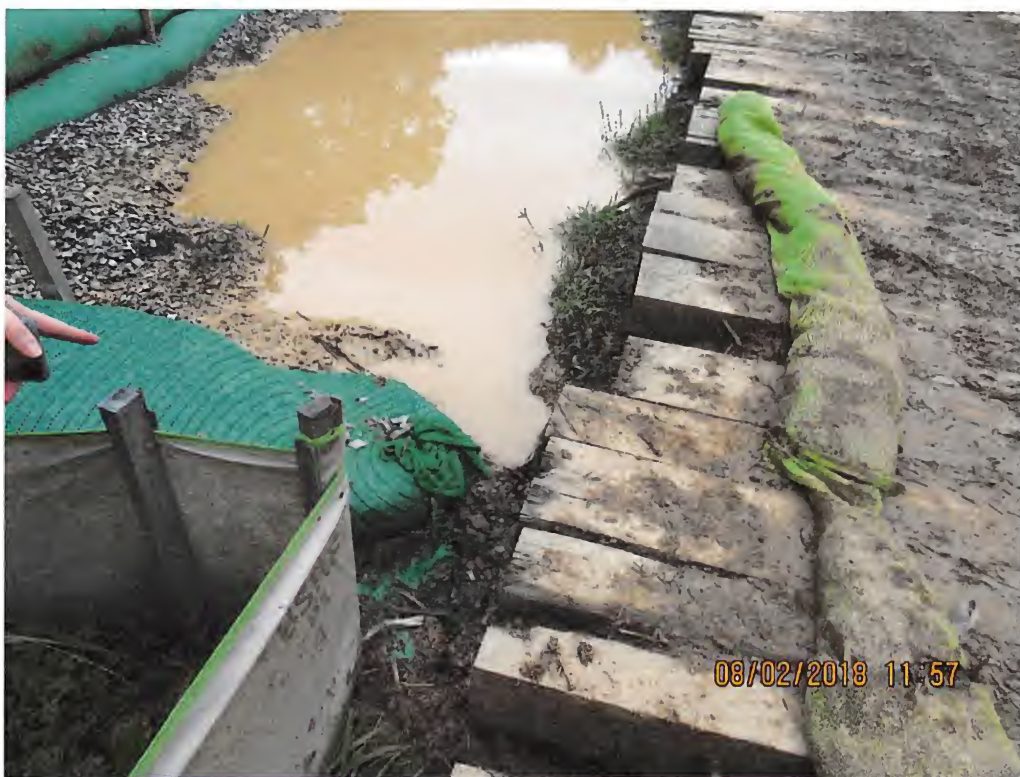
Source of sediment laden water in Slate Run.

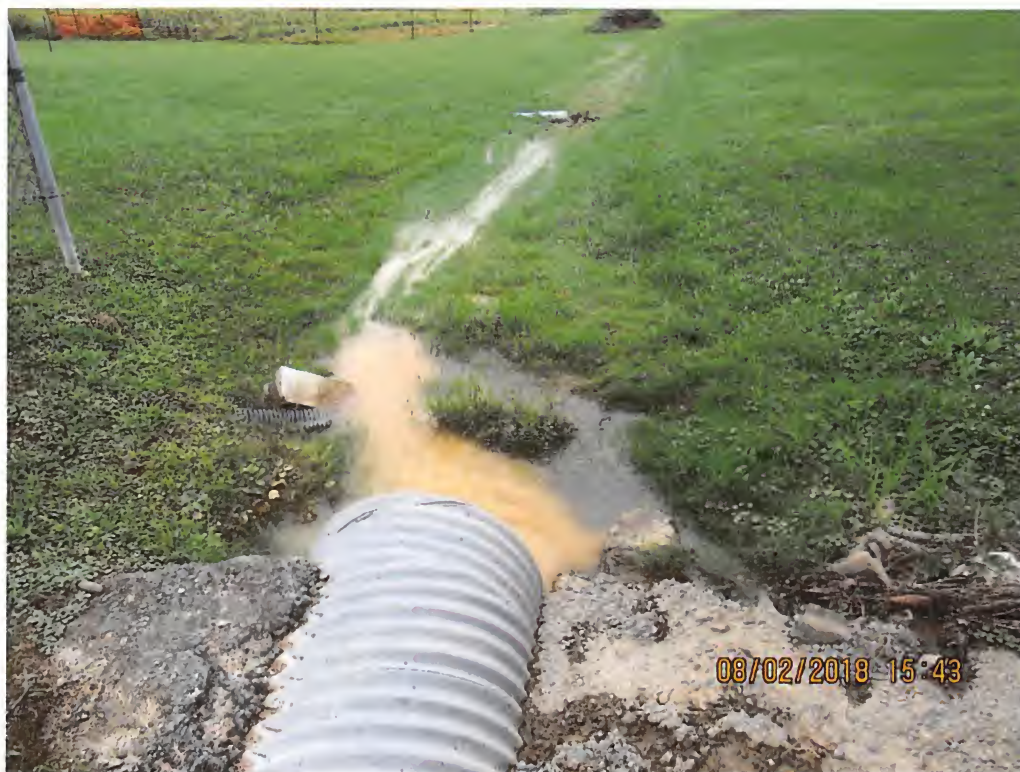
Sediment laden water near Lindsie Methodist Church.

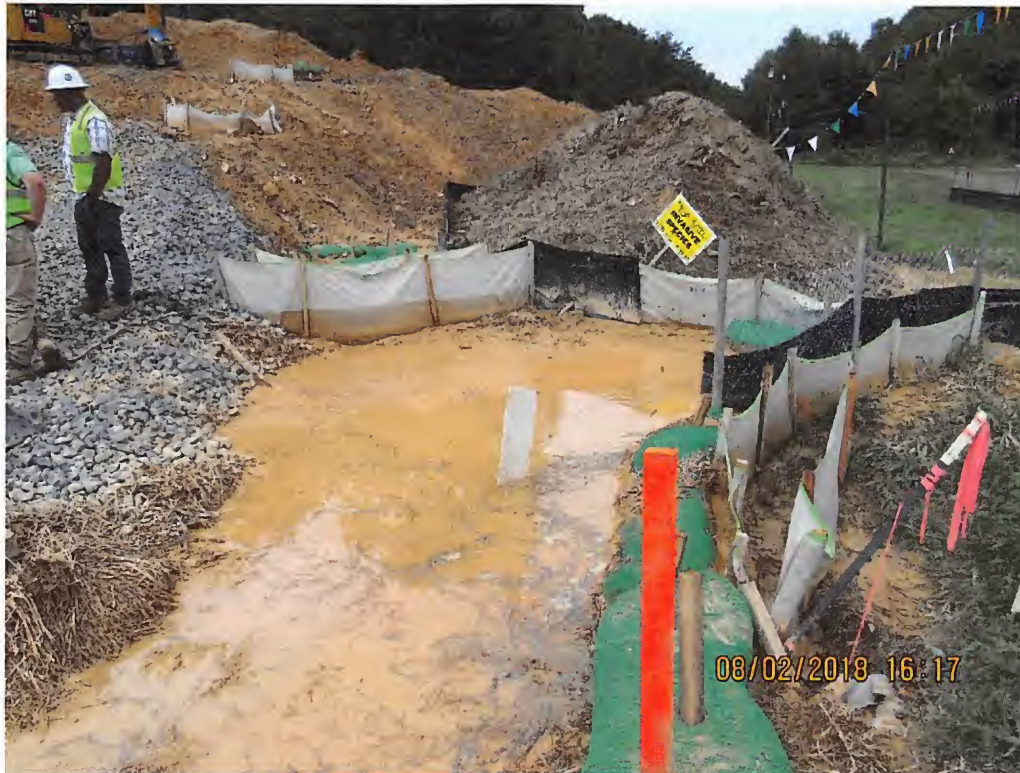
Station 10270+00, sump is full.
